NBSIR 80-2058 (ONR)

Studies of Microscopic Aspects of Wear Processes in Metals

April 1, 1979-December 31, 1979
Annual Report
N00014-79-F-0034
NR 091-011/2-14-79(473)
Issued June 1980

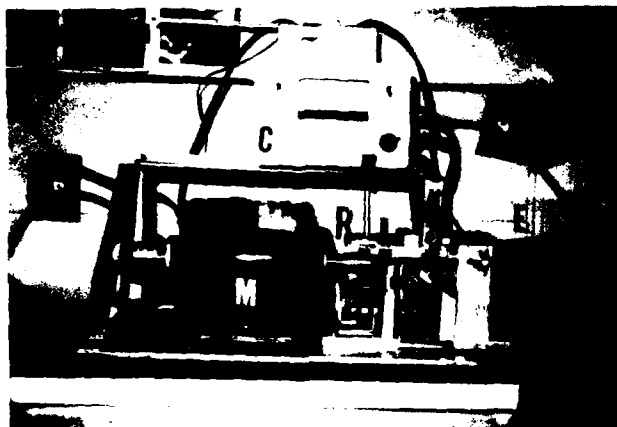
Fig. 1. Wear test apparatus showing motor (M), ring (R), controller (C), specimen arm (A), enclosure (E).

Two wear test systems were developed for use in this study. One involved a test configuration of conventional block-on-ring geometry utilizing a variable speed 1/4 h.p. electric motor with a replaceable standard wear ring (3.49 cm diameter, 8.7 mm wide) attached to the motor shaft to provide sliding motion for

the wear test (Fig. 1). The test specimen was loaded on top of this ring and was held in place on an instrumented arm which was free to pivot in a vertical plane. The holder used for the rectangular block specimens (0.63x1.27x2.54 cm) was designed so that weights could be placed over the contact in order to vary the load. A load of 10 N was used in all tests with this system. A clear plastic enclosure around the wear contact region was used to maintain a flowing argon atmosphere and a low humidity level during the dry wear tests. A cam surface on the wear ring holder on the motor shaft was used to open and close a switch in a D.C. circuit, once per cycle. This switch was used to synchronize data sampling with the motor shaft position to reduce the contribution to displacement due to the wear ring surface run-out. Surface run-out was typically 10 μm , however, this data sampling method reduced the effect by a factor of 100. Wear debris was collected on a clean glass slide positioned below the wear contact. All the experiments carried out with this system used a sliding speed of 20 cm/s (110 RPM).
